AG-AVT-140

Corrosion Fatigue and Environmentally Assisted Cracking in Aging Military Vehicles

Published March 2011

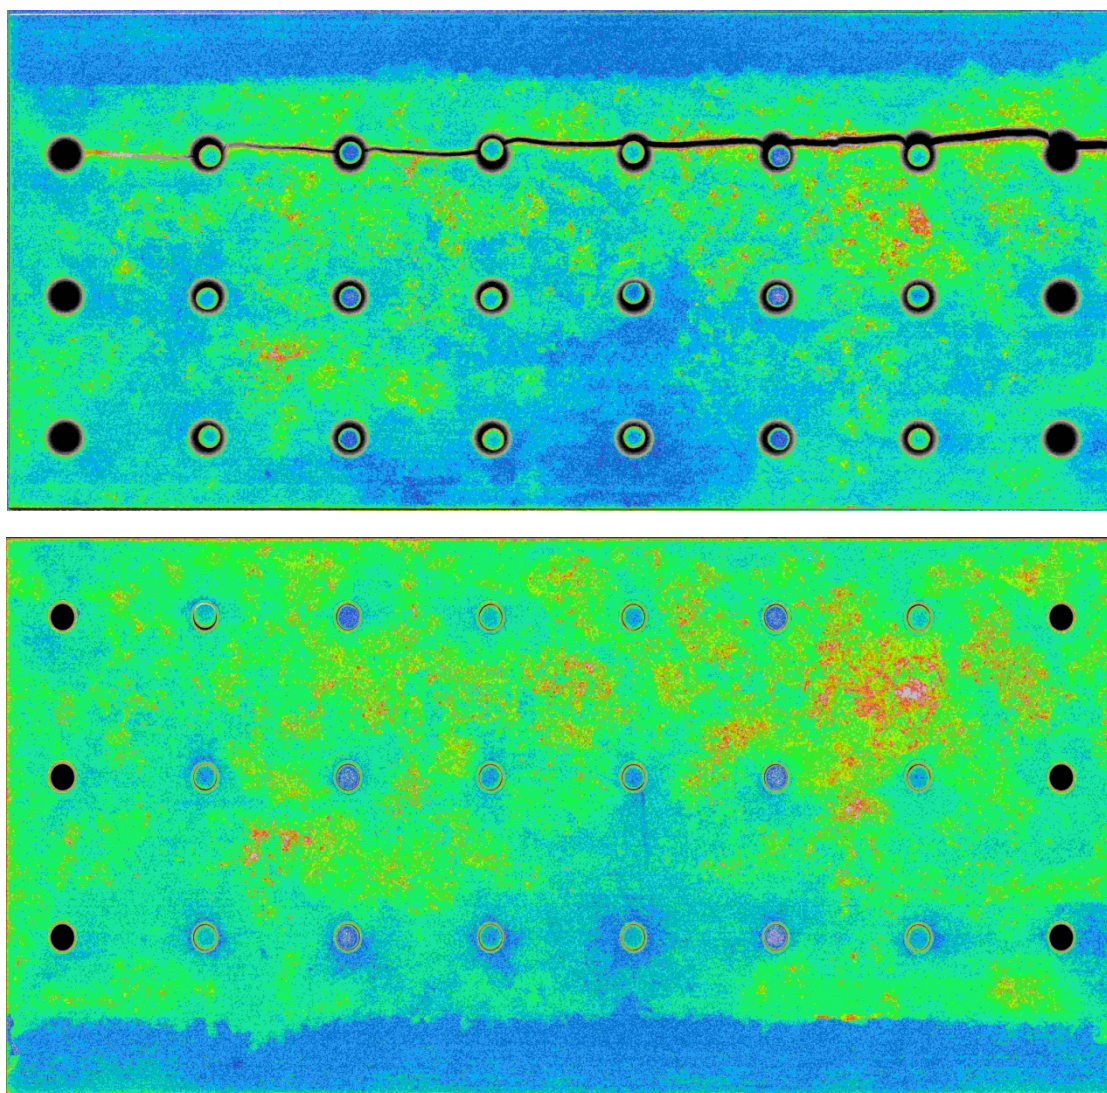
Figure 16-4: Pseudo-Colored Digitized X-Ray (DXR) Thickness Maps Showing Corrosion Distribution in Countersunk (upper image) and Driven (lower image) Sheets of Specimen #035 (higher resolution grey scale images are used for quantitative analysis).

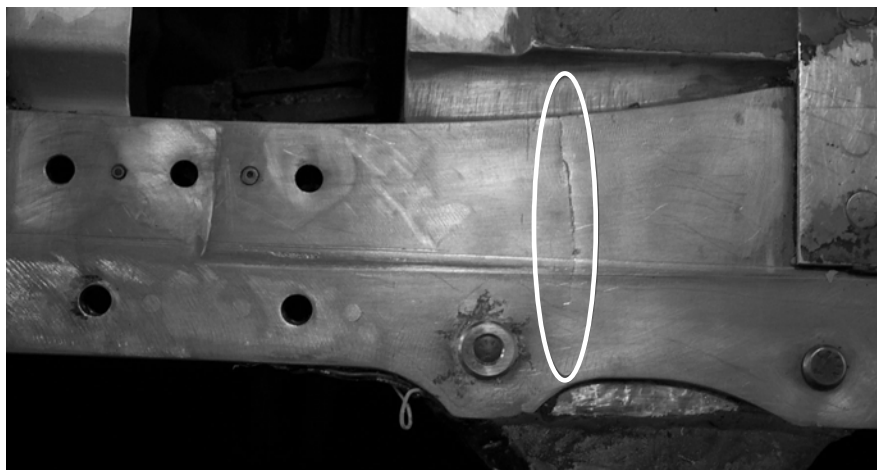
A full scale F-18 wing test (FT245) was conducted at the National Research Council (NRC) Canada under the International Follow-On Structural Test Project (IFOSTP) supported by The Canadian Forces (CF) and The Royal Australian Air Force (RAAF). During the test, a long fatigue crack of 46 mm (1.81 inch) was discovered on the right hand upper Outboard Longerons (UOL) of the centre fuselage at 2932 Simulated Flight Hours (SFH), as shown in Figure 17-1. In this test, the fuselage was used as a transition structure, and was a retired United States Navy (USN) F-18 aircraft that had been in-service for ten years (1984 – 1994), Rutledge et al. [1]. Extensive corrosion was reported on the UOL by the US Navy (USN) during its service life, which was repaired (blended out) [1]. During the full scale wing test, the crack in the component was discovered after a fairing and sealant had been removed to perform a scheduled life enhancement procedure. Corrosion pits were found in the area near the apparent crack nucleation site. Since the full scale wing test was conducted in an environmentally controlled facility, it was reasonable to assume that these pits formed in-service and went undetected after the last maintenance cycle prior to the aircraft being retired. This cracking case was used to demonstrate and validate the applicability of a Holistic Structural Integrity Process (HOLSIP) based corrosion fatigue analysis methodology and tool.

Figure 17-1: Fatigue Crack on the Right UOL of F18 Central Fuselage.

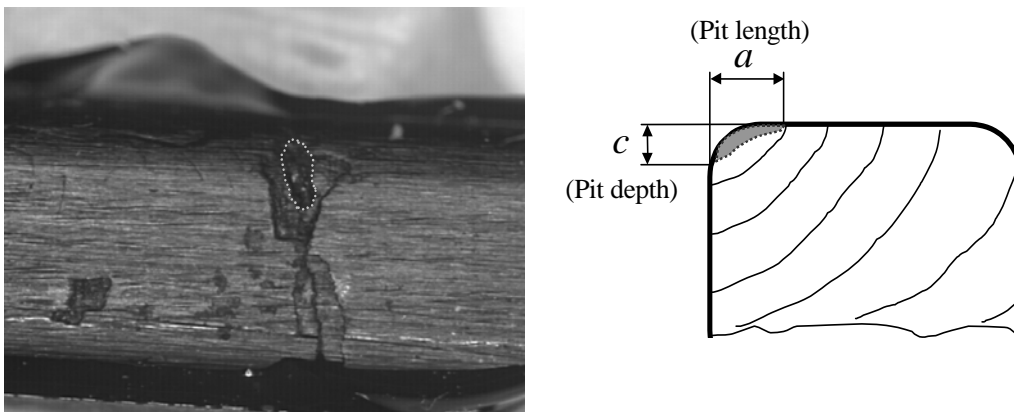
A replica was taken to verify that the crack nucleated from corrosion pits (see the dotted line in Figure 17-3) that were present at the round corner. A corner crack model was thus added to ECLIPSE in order to simulate this cracking scenario. The combined length of the pits along the thickness direction was approximately 0.63 mm (0.0248 inch), and the pit depth (shortest dimension), which occurred in the width direction was approximately 0.44 mm (0.0172 inch).

Figure 17-3: Corrosion Pits and Cracking Scenario.

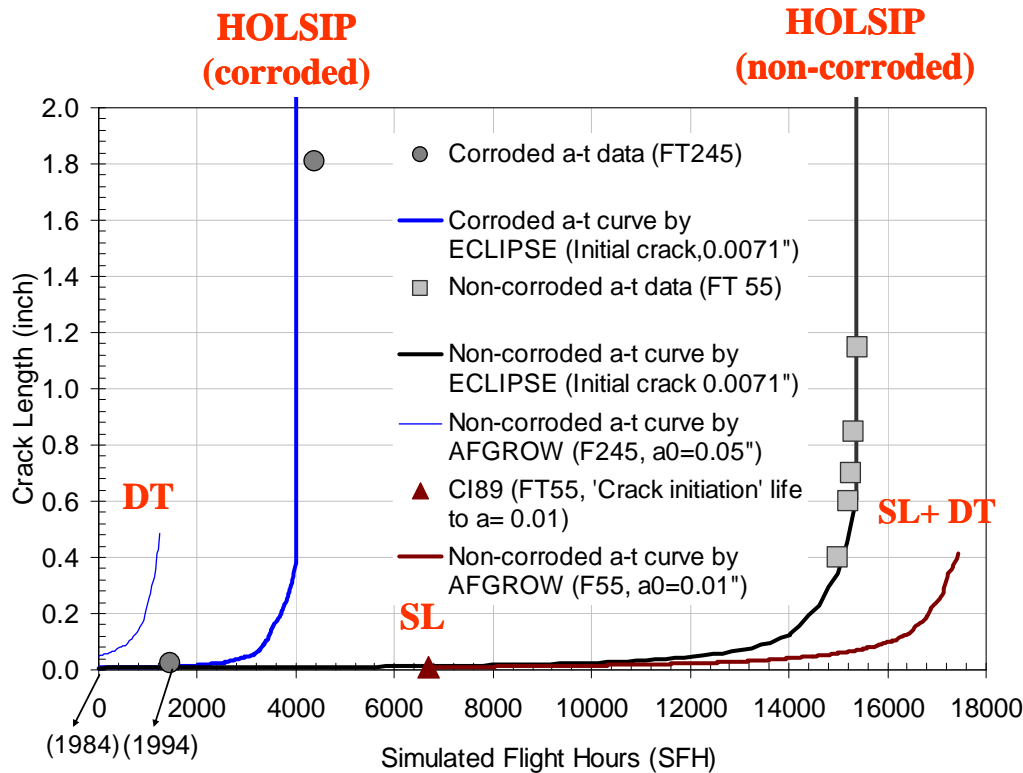
Figure 17-7: Life Comparison Between Corroded and Non-Corroded UOL.

In Figure 17-7, the result of a Damage Tolerance (DT) analysis is also presented. The DT analysis was carried out using AFGROW, and a typical initial crack size of 1.27 mm (0.050 inches). It is shown that the typical DT analysis clearly underestimated the life of the corroded UOL, without including the corrosion effect.

As the F-18 was originally designed based on the Safe Life (SL) approach, a “Crack Initiation” software (CI89) which was specifically calibrated for the CF-18 material and load spectra, was used to estimate the ‘crack initiation’ life (time to a crack size of 0.25 mm, or 0.010 inches). The CI89 results, labeled as SL, are presented in Figure 17-7. As can be seen, since the SL approach did not consider corrosion effects, its predicted life is longer than that of the corroded UOL, but less than the life of non-corroded UOL. Further analysis was performed to continue a DT analysis (AFGROW) from the 0.010-inch crack to failure, the total life (i.e., sum of CI89 and DT lives) is presented in Figure 17-7, labeled as SL+DT. It is shown that the SL+DT total life approach overestimated the life of the non-corroded UOL, while the HOLSIP approach provided a result close to that of the test.

In summary, both analytical and test results showed that the corrosion pits significantly decreased the life of the UOL. The HOLSIP/ECLIPSE analysis provided most reasonable results for both corroded and non-corroded cases.

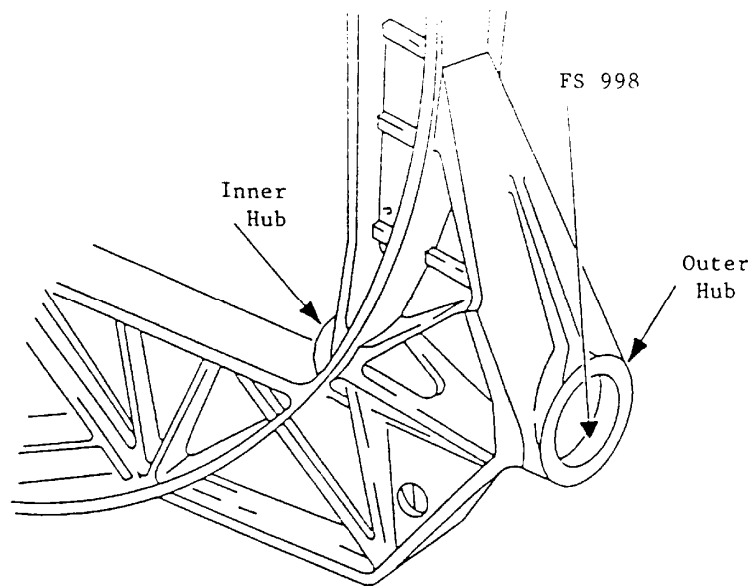
This case study examines the failure of fuselage frames on the now-retired USAF C-141 aircraft. The component experiencing the problem was the frame at Fuselage Station (FS) 998. In particular, cracking was occurring in a hub for a main landing gear attachment point (Figure 18-1). Special concern was placed on this component because it was largely expected to be an ‘infinite life’ component, at least in the area where cracking was occurring. The discovery of cracks, not explained by any analyses, had the USAF confronting a very likely possibility of wholesale frame replacement throughout the fleet, which would have been a very costly option in terms of both dollars and asset availability. Replacing the FS 998 frame is major surgery.

Figure 18-1: Drawing of Main Frame Landing Gear Hub.

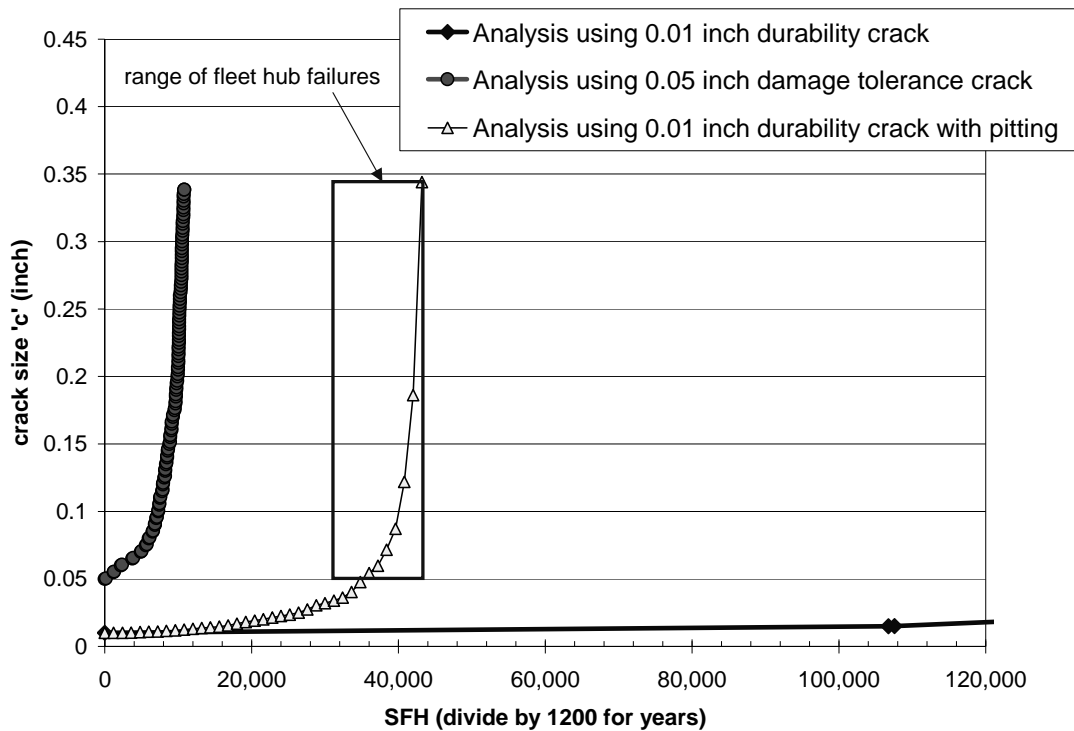
Figure 18-3 shows the results of the demonstration analyses. In practice, the fleet was experiencing failures in the range of 35,000 to 43,000 flight hours. Using traditional analysis techniques and the common durability crack size of 0.25 mm (0.01 inch), the hub showed flat crack growth (practically speaking, infinite life). On the other extreme, by assuming a damage tolerance crack size of 1.25 mm (0.05 inch), the component appeared to have an extremely short service life, which results in a heavy and expensive inspection burden.

**Figure 18-3: Crack Growth Analysis of Main Landing Gear
Hub Showing Traditional and HOLSIP Analyses.**

However, by including corrosion pitting in the traditional durability analysis, the life capability is reduced considerably but accurately (less than with damage tolerance assumptions) and estimates structural capability in the range of the fleet failures. The impact of corrosion is clear and further demonstrates the importance of holistic structural integrity considerations in aircraft maintenance, and also illustrates the power of these methods to identify corrosion-susceptible structure during design.

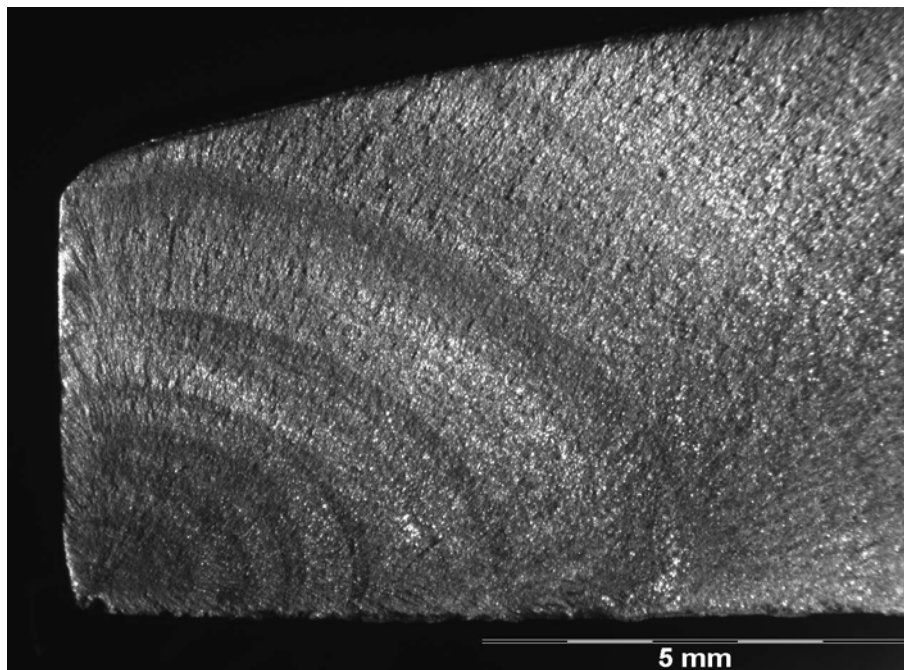
Fracture analysis was conducted using an optical stereoscope and an optical microscope. The fracture face revealed beach marks at lower magnification (Figure 19-1) and striae at higher magnification, which indicated fatigue was the primary crack propagation mechanism.

Figure 19-1: Optical Micrograph of Fracture Face Showing Beach Marks.

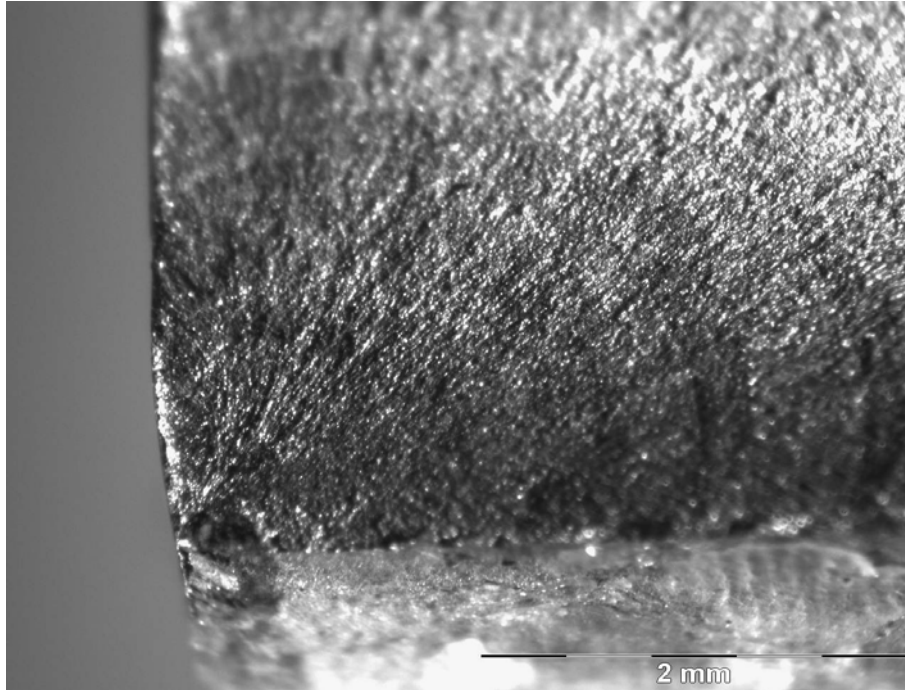
River marks on the fracture pointed back to a single origin at a corrosion pit (Figure 19-2) that was approximately 175 microns deep and hemispherical in nature. Other surface pitting was evident in areas adjacent to the failure location (Figure 19-3).

Figure 19-2: Optical Micrograph Showing Pitting at Origin and River Marks Emanating from Region.

Although the components contained a corrosion protection coating in service, the contact of a stainless steel retaining ring against the aluminum, in combination with the dynamic operating environment, is believed to have damaged the coating. Unrelated maintenance activities on these components may also have adversely affected coating integrity. Once the coating was compromised, the presence of a crevice and galvanic couple (between the retaining ring and the component) and a harsh operating environment made the component very susceptible to pitting. The violation of surface integrity caused by the pitting then made the part susceptible to corrosion fatigue.

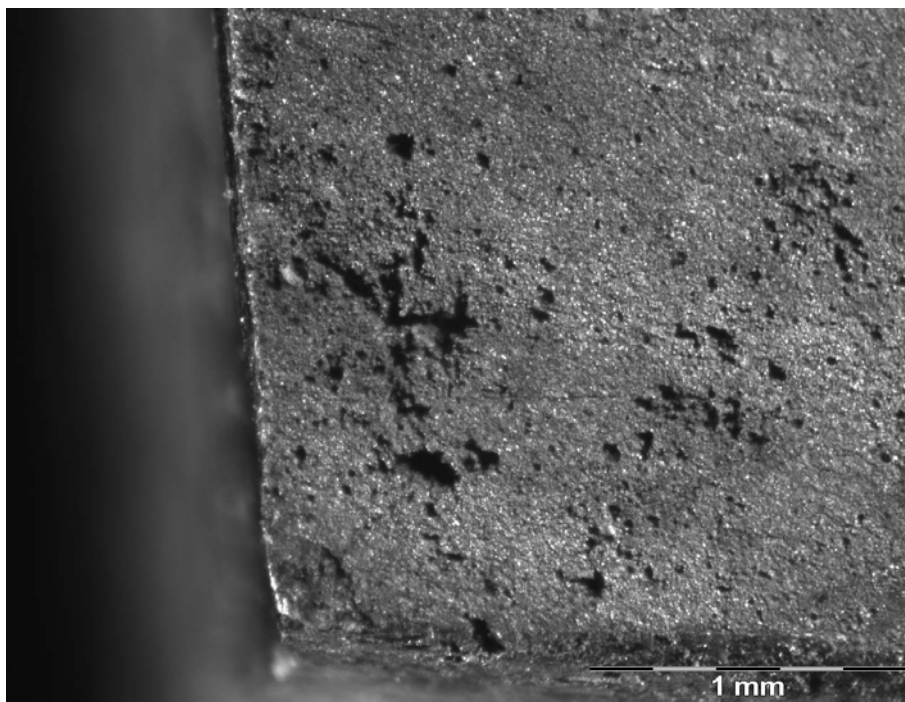
Figure 19-3: Optical Micrograph of Surface Perpendicular to Fracture Plane Showing Clusters of Corrosion Pits.

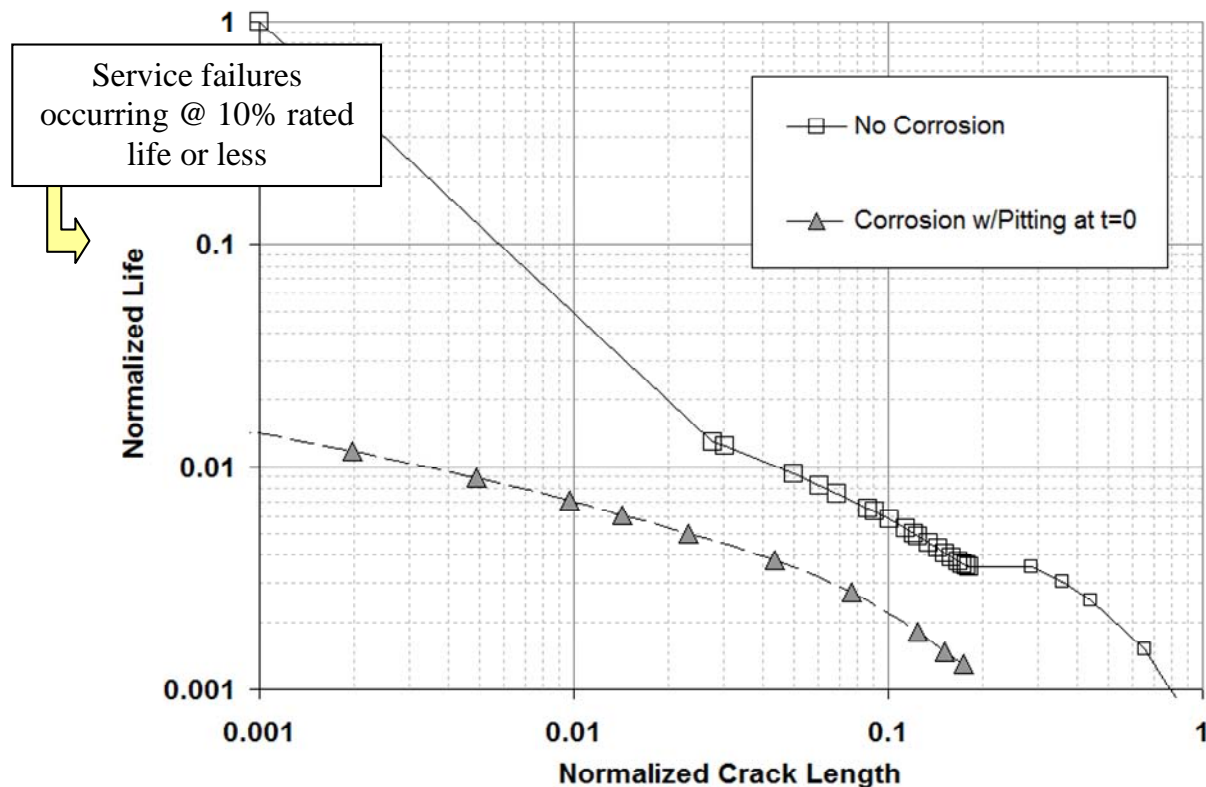
This exercise was repeated assuming the presence of a 175-micron deep, hemispherical corrosion pit at the critical location on the component. In the models used, the presence of the pit amplifies the beta solution associated with the crack, which causes a shift in stress intensity, an increase in crack growth rate, and a decrease in fatigue life [3]. The results shown in Figure 19-4 illustrate the very severe influences of a corrosion pit in this scenario. If the pit had existed from time zero, the analysis shows that the part would only have about 1.5% of its original rated life capability. In reality, the components are failing at closer to 10% rated capability, but this is simply an indicator that the pits are not in the components at manufacture; rather, they form during operational usage. However, it is safe to say that once the coating is compromised, pitting is likely to follow, and once the pits form, failure of the component will follow shortly thereafter.

Figure 19-4: Plot of Normalized Life versus Normalized Crack Length for a Helicopter Main Rotor Component With and Without Corrosion Pitting.

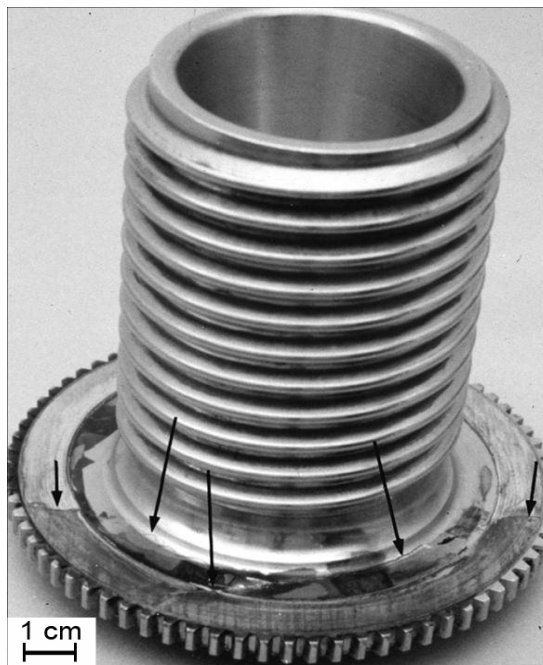
Figure 20-7 shows the extent of cracking of the bolt. The crack was broken open and the fracture surfaces were examined.

Figure 20-7: Case History 20.5.1 – The Cracked Blade-Retaining Bolt (the arrows point to the crack).

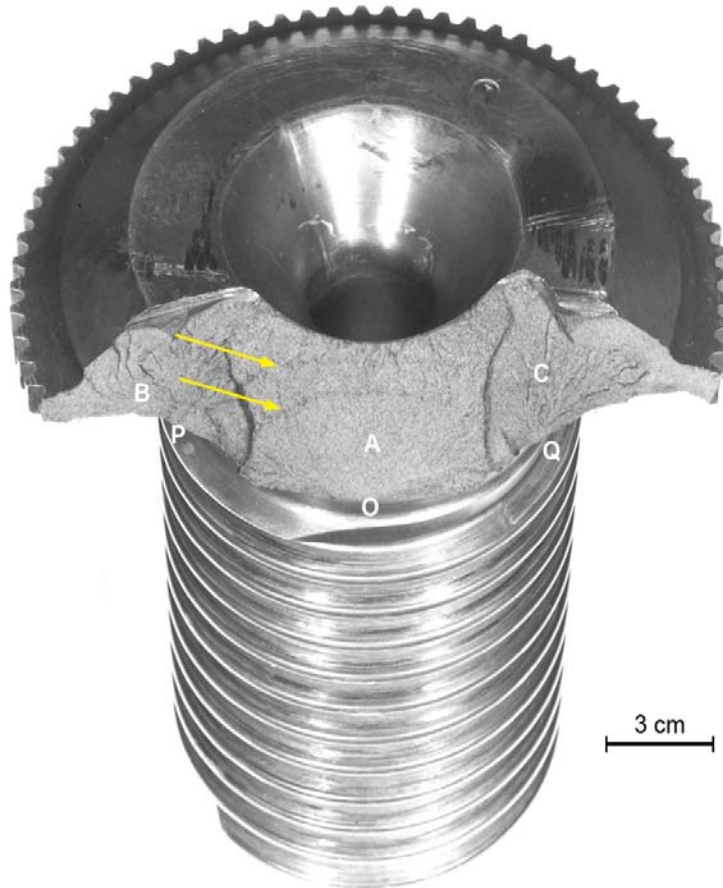
Figure 20-8 shows the main part of the broken-open bolt. The main crack (A) initiated at O, and the two adjacent cracks (B and C) initiated at points P and Q, respectively. Note the two progression marks (arrowed) on the fracture surface of crack A. These marks are due to locally higher roughness, and may signify peak loads that occurred during service.

Figure 20-8: Case History 20.5.1 – Fracture Surface of the Blade-Retaining Bolt (the main crack (A) initiated at O, and the two adjacent cracks (B and C) initiated at points P and Q, respectively – note the two progression marks (arrowed)).

Optical examination showed that the three crack initiation sites O, P and Q had their origins at small pits near the radius run-out under the bolt head. The pits were surrounded by semi-circular regions having a black-brown colour. Apart from these regions, whose greatest depth was about 250 µm, most of the fracture surface was clean.

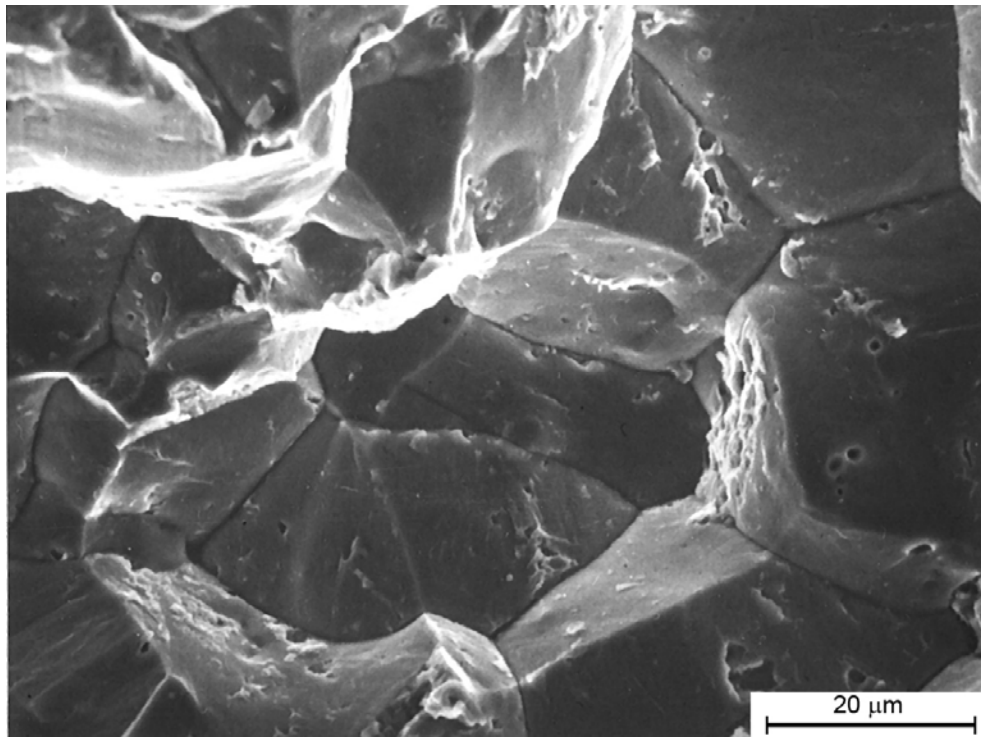
SEM fractography showed mainly clean intergranular fracture typical of IHE, e.g., Figure 20-9. However, examination of crack initiation site O showed not just the pit at the origin, Figure 20-10, but also deposits on intergranular fracture in the semi-circular region surrounding the pit, see Figure 20-11. Energy Dispersive Analysis of X-rays (EDAX) indicated that these deposits were rich in cadmium. Intergranular fractures similarly contaminated with cadmium were present in the semi-circular regions surrounding the pits at the crack initiation sites P and Q. This cadmium contamination suggests that all three semi-circular regions had been present before the last plating operation, most probably owing to IHE from the previous plating operation.

Figure 20-9: Case History 20.5.1 – Example of Clean Intergranular Fracture.

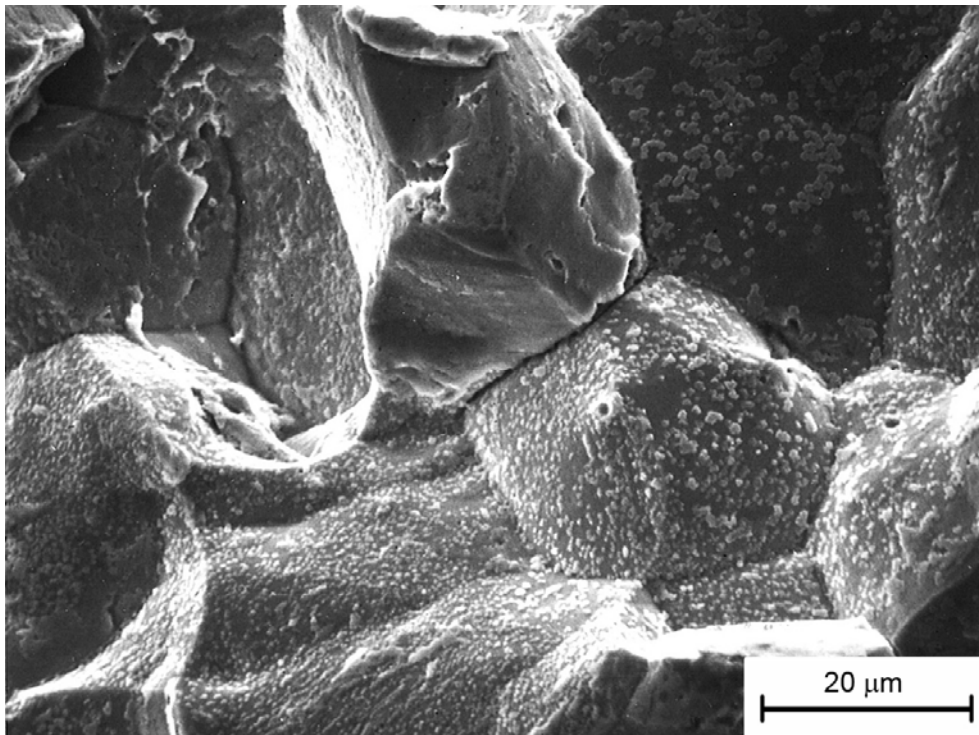
Figure 20-11: Case History 20.5.1 – Detail from Figure 20-10 Showing Deposits on the Intergranular Fracture (EDAX indicated that these deposits were cadmium-rich).

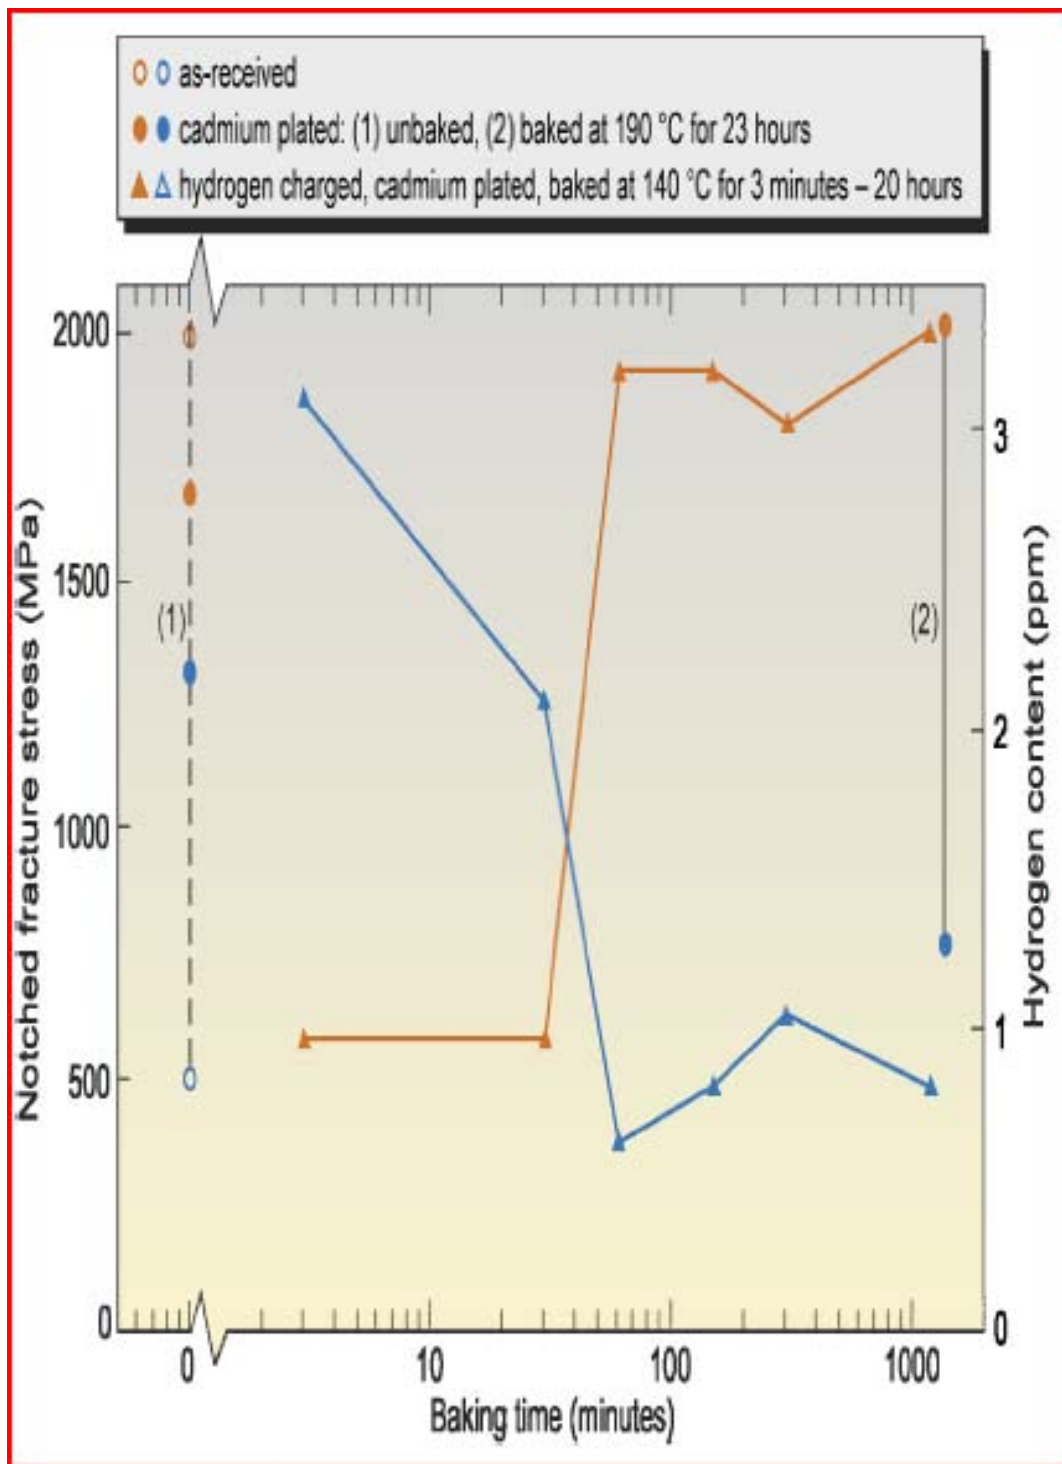
The specimens were tested to failure at a cross-head displacement rate of 2.1×10^{-4} mm/s. After fracture they were immediately stored in liquid nitrogen to await hydrogen analysis *in vacuo* at 600°C. The results of the tests and analyses are shown in Figure 20-13. There are several observations to be made:

- 1) After baking to remove any diffusible hydrogen, the as-received specimen contained about 0.8 ppm of trapped hydrogen (this trapped hydrogen was removed by hydrogen analysis *in vacuo* at 600°C). The fracture stress of this specimen was 1985 MPa, and is a reference for the degree of embrittlement of the other specimens.
- 2) Baking had a beneficial effect on the fracture stress of cadmium plated specimens, and there was a concomitant decrease in hydrogen content from 2.3 ppm to 1.3 ppm.
- 3) Baking times longer than 30 minutes removed substantial embrittlement due to hydrogen charging followed by cadmium plating.

Figure 20-13: Case History 20.5.1 – Results of the Notched Tensile Tests and Hydrogen Analysis.

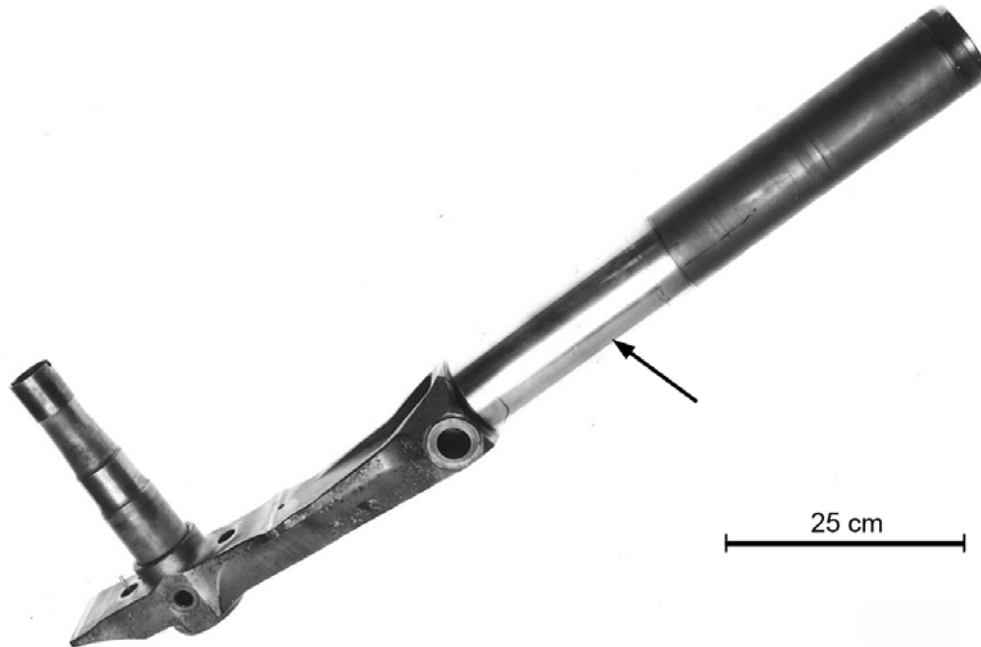
The assembly is shown in Figure 20-14. It was made from 35NCD16 low alloy steel heat-treated to a Rockwell hardness of 51 HRC, corresponding to a tensile strength of about 1793 MPa. The nominal chemical composition in wt. % is: 0.4 C, 4.0 Ni, 1.8 Cr, 0.45 Mn, 0.45 Mo, 0.03 V, 0.3 Si.

Figure 20-14: Case History 20.5.2 – Main Undercarriage Half-Fork Assembly Sent for Examination (the arrow points to the chromium plated cylindrical section).

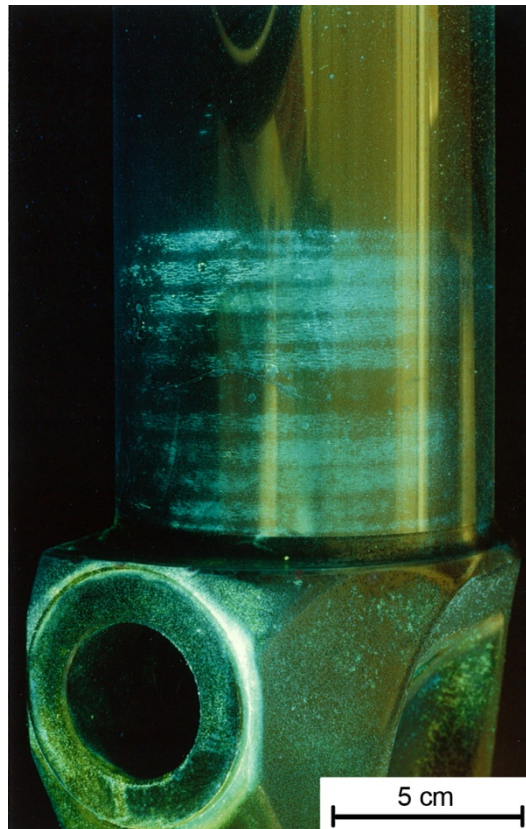
The arrowed cylindrical section in Figure 20-14 had been hard-chromium plated. Dye penetrant showed helically banded cracking at the lower and upper ends of the section, e.g., Figure 20-15.

Figure 20-15: Case History 20.5.2 – Example of Helically Banded Cracking in the Hard-Chromium Plate (see Figure 20-14 for the location).

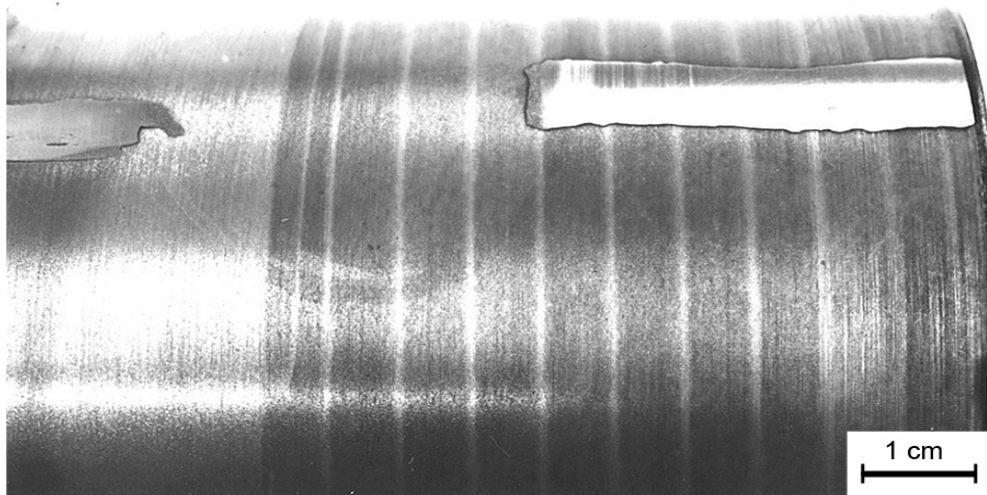
The chromium plating was removed from selected areas of the cylindrical section by chemical dissolution in sodium hydroxide solution. Dye penetrant NDI of the stripped areas revealed the same pattern of helically banded cracking in the steel. Since this form of banding is characteristic of grinding damage, the steel surface was etched with nital. Helical dark etching bands confirmed the presence of grinding damage, see Figure 20-16. Discussions with the OEM suggested that this damage had occurred during overhaul of several batches of the half fork assemblies, owing to grinding conditions beyond the specified limits, i.e., abusive grinding.

Figure 20-16: Case History 20.5.2 – Helical Dark Etching Bands Indicating Grinding Damage of the Steel Surface of the Lower Part of the Cylindrical Section (note the irregular areas with retained hard-chromium plate).

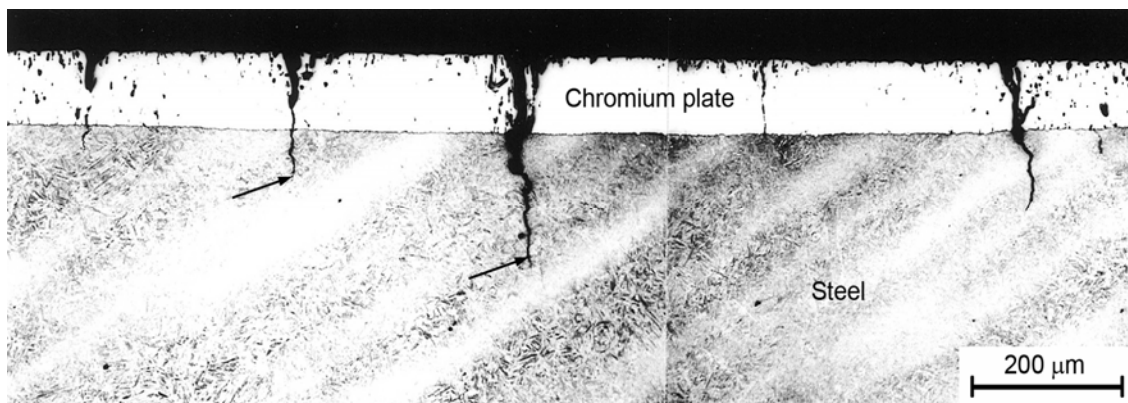
Several cross-sections were made of the grinding damage in non-stripped areas. Figure 20-17 gives an example close to the lower end of the cylindrical section. There were numerous intergranular cracks in the steel, penetrating along prior austenite grain boundaries to a depth of about 130 μm . Most of these cracks were associated with cracking in the overlying chromium plate, as in Figure 20-17, but some were not. This suggests that initiation of (some) cracks in the steel may have preceded cracking of the chromium plate. Be that as it may, the initially intergranular nature of the steel cracks indicates that they were due to IHE. In turn, high tensile stresses introduced by abusive grinding could have caused IHE, and this may well have been exacerbated by hydrogen pick-up during electroplating.

Figure 20-17: Case History 20.5.2 – Typical Cross-Section Through a Non-Stripped Area Containing Grinding Damage (the arrows point to transgranular fatigue cracks growing from intergranular crack).

The arrows in Figure 20-17 point to transgranular cracks growing into the steel from the intergranular cracks. These transgranular cracks were found only near the lower end of the cylindrical section, where the service stresses would have been highest. From their transgranular nature and location it seems most likely that these were fatigue cracks.

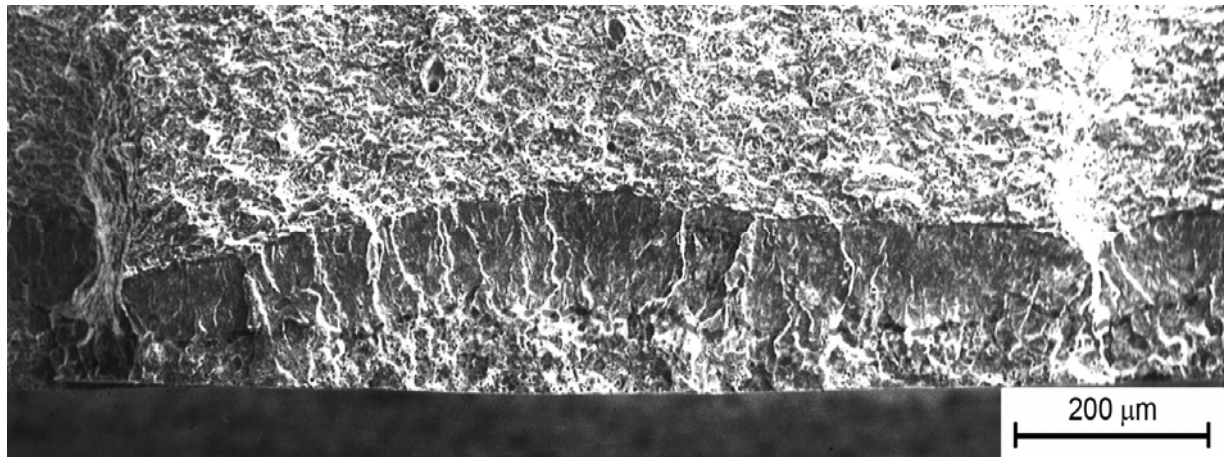
The area containing suspected fatigue cracks was broken open. SEM fractography confirmed that fatigue cracks were growing from the intergranular cracks. An example is shown in Figure 20-18, which indicates the three successive regions of intergranular cracking, transgranular fatigue cracking, and overload fracture. More detailed observations were hindered by extensive pitting corrosion on the intergranular and fatigue fracture surfaces.

Figure 20-18: Case History 20.5.2 – A Broken-Open Crack Showing Intergranular Fracture Followed by Transgranular Fatigue Fracture and Overload Fracture.

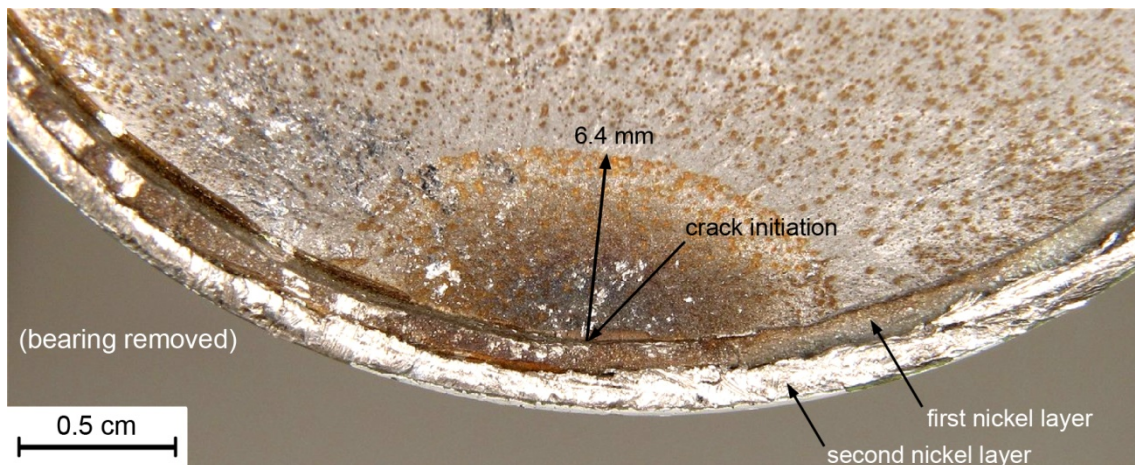
- 1) Both crack initiation regions had discolorations grading from black to light brown. The spindle-side fracture surface was also discoloured by post-failure rust spots.
- 2) The spindle-side steel surface was covered by two nickel plating layers, see Figure 20-21.
- 3) Side surface corrosion was present just below the fork-side fracture surface, see Figure 20-22. This corrosion is seen in more detail in Figure 20-23, which also shows a thin remnant of nickel plating and tool marks owing to grinding away excess nickel plate.

Figure 20-21: Case History 20.5.3 – Spindle-Side Fracture Surface.

- 2) Figure 20-21 and Figure 20-22 show discolorations grading from black to light brown on the fracture surfaces of the crack initiation region. These discolorations are the result of progressive oxidation during crack growth, and their gradual transition from black to light brown is characteristic for both stress corrosion and corrosion fatigue in steels. On the other hand, the service loading on the carriage assembly would have been mainly cyclic (flaps in, flaps out) rather than sustained. (N.B.: See Section 20.3 2) also.)

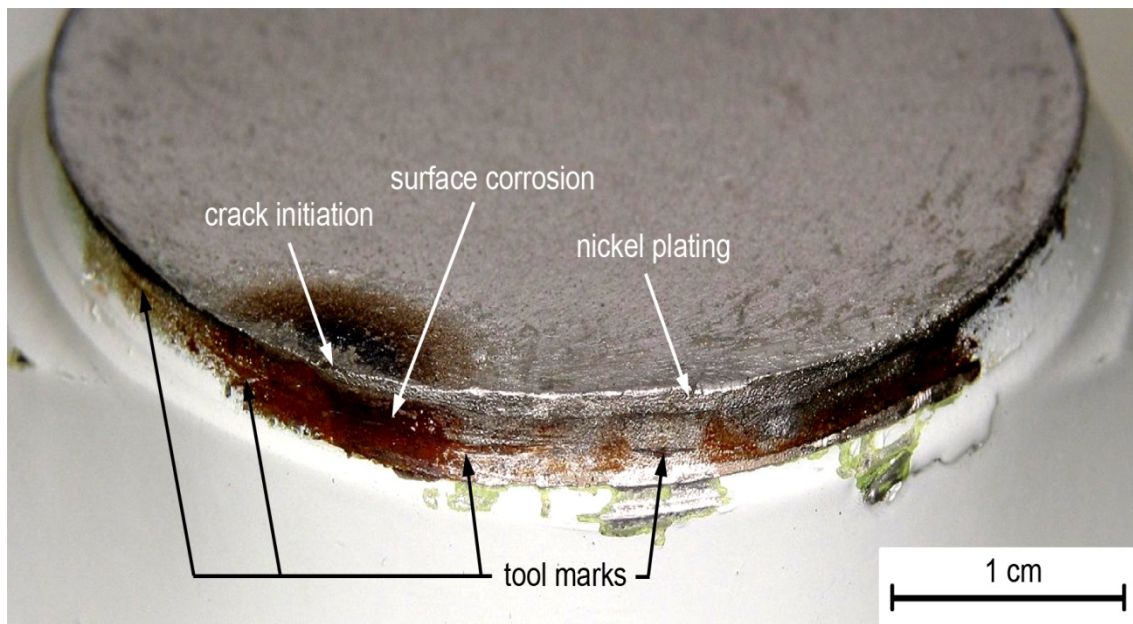
Figure 20-23: Case History 20.5.3 – Side Surface Around Fork-Side Crack Initiation Region.

- 2) *Fork-Side Cross-Section*, Figure 20-25. The radius area was unprotected by electroplating and paint, and had undergone corrosion (also visible in Figure 20-23). Thin white-etching layers at the steel surface indicate untempered martensite caused by grinding.

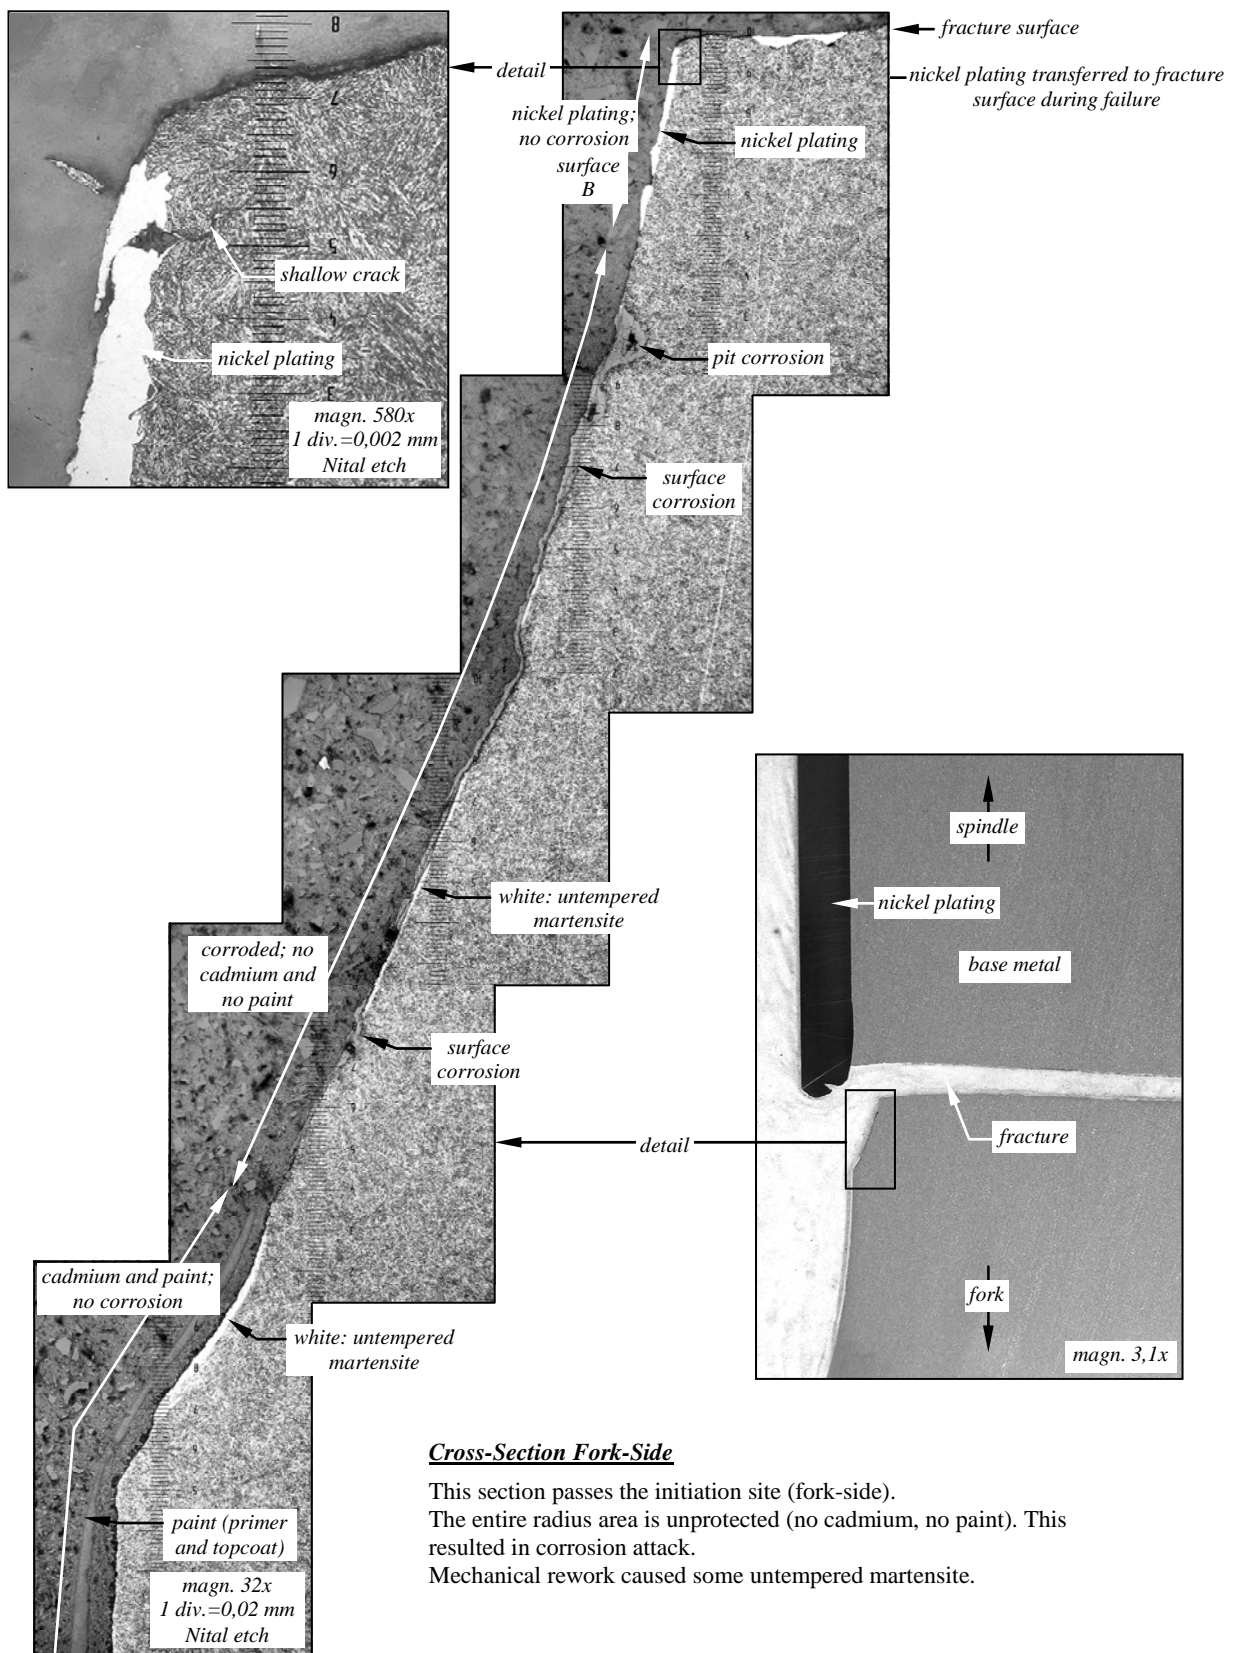
Cross-Section Fork-Side

This section passes the initiation site (fork-side). The entire radius area is unprotected (no cadmium, no paint). This resulted in corrosion attack. Mechanical rework caused some untempered martensite.

Figure 20-25: Case History 20.5.3 – Metallographic Cross-Section Through the Fork-Side Crack Initiation Region (Note: Surface B matches surface A in Figure 20-24).

- 5) Figure 20-25 shows an anomaly, namely that the operator indicated nickel plate to have been transferred to the fracture surface during failure. This is most unlikely. However, the operator's report mentioned that the two fracture halves were reassembled to visualize the nickel plating transition in the radius. It is possible that this reassembly – which should not have been done! – caused smearing of some loosened or protruding nickel plate onto the fracture surface.
